Specific Site Assessment for Coal Combustion Waste Impoundments at Intermountain Generating Station

Delta, Utah

April 2011
Project 092884

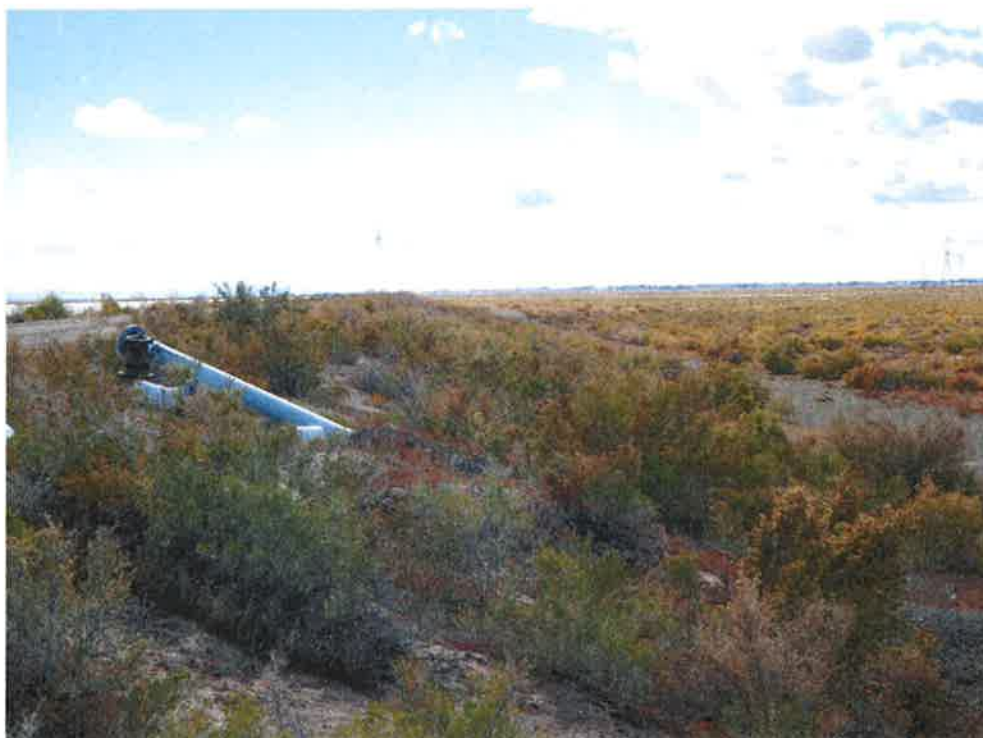
Basin are sparsely covered with vegetation consisting of greasewood shrubs, wheat grass and other native vegetation. The downstream slopes showed no signs of significant erosion. However, minor erosion rill on the downstream slope of the Wastewater Holding Basin west embankment was observed, most likely due to surface runoff.

Photo 12: Wastewater Holding Pond, looking south at west dike downstream slope.

We recommended IPSC personnel develop and document formal inspections of the CCW impoundments, at a minimum to be performed annually by plant staff. We recommend a brief daily check inspection be conducted by IPSC personnel and that a written record be maintained for the monthly inspections being conducted by IPSC personnel. Also, continue efforts to repair minor erosion rills observed on the embankment slopes. Due to the lack of erosion protection, minor erosion rills should be repaired promptly to prevent extensive damage to the embankment slopes.
